TECHNOLOGY FOR REPAIRING DAMAGED 3LPE INSULATION WITH ANTICORRay REP MATERIALS

3.1 REPAIRING TECHNOLOGY FOR DEEP DAMAGES – for the metal surface, sized under 100 x 200 mm.

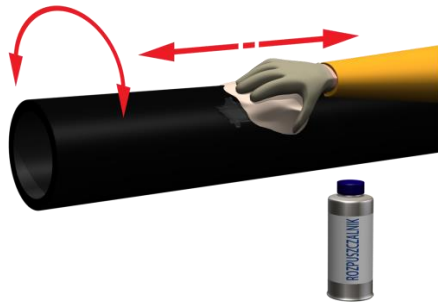
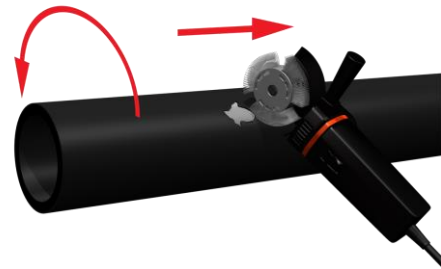
- Remove the loose 3LPE coating not adhering to the pipe.
- Chamfer the edged of 3LPE coating down to an angle of 15°.
- Degrease the exposed surface of the steel pipe and the adjacent 3LPE insulation surface.
- Remove the rust other pollutions from the exposed steel pipe surface with the Bristle Blaster® device and continue to obtain a cleanliness level Sa 2½.

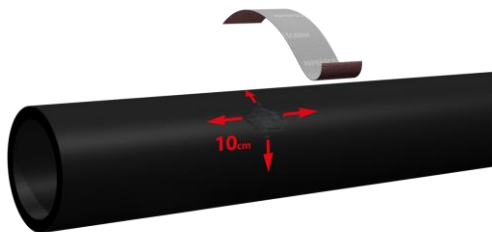
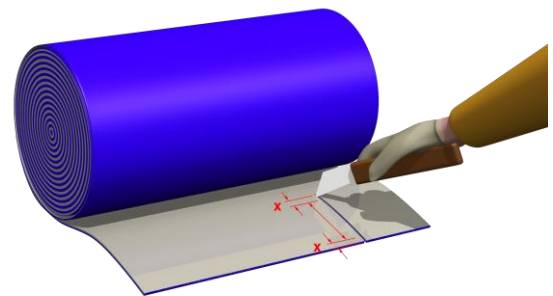
- Roughen the 3LPE surface adjacent to the damage at a distance of 10 cm away from the edge of the damaged place.
- Cut out a suitable piece of repair patch ANTICORRay REP with a 50 mm allowance towards the edge of the damaged place.
- Round off the patch corners.

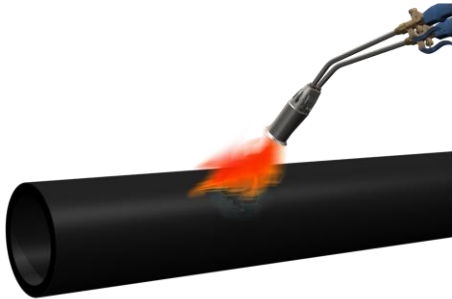
- Heat up the place under repair up to $70 \pm 80^{\circ}\text{C}$.

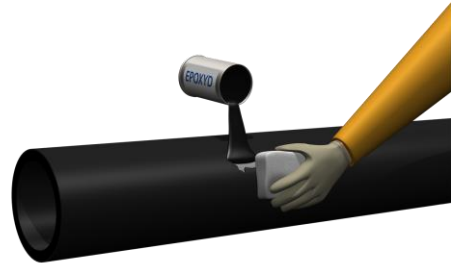
- Mix thoroughly ingredients A and B of epoxy primer ANTICOR Ray Primer 801.
- Apply the primer on the steel surface.

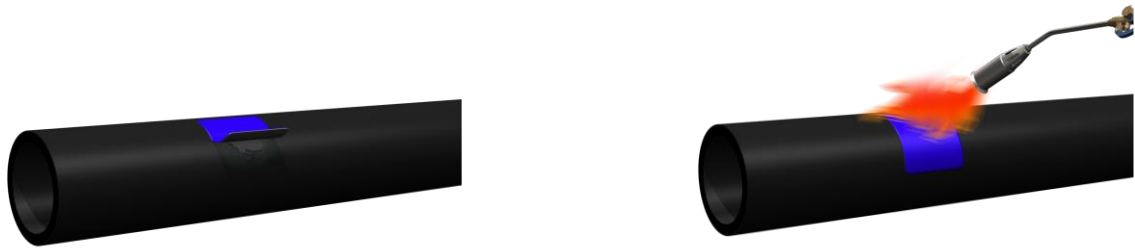
- Place the patch on the place under repair with 50 mm overlap on the 3LPE coating.
- Hold the patch in the burner flame.
- Remove air bubbles, if any, using a silicon roller.
- Stop heating up the patch when an adhesive flash has appeared in the periphery.

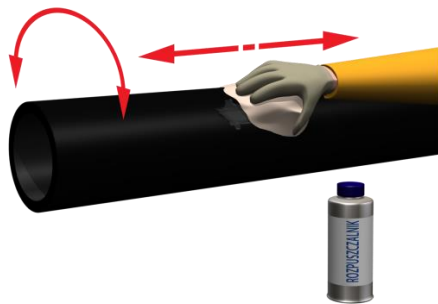
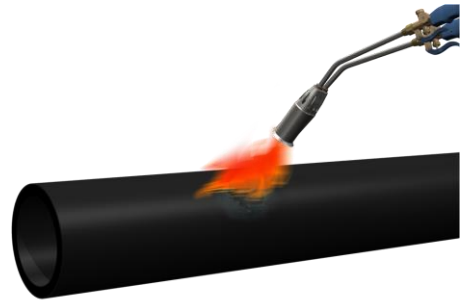
- Remove the loose 3LPE coating not adhering to the pipe.
- Chamfer the edges of 3LPE coating at the damaged place.
- Degrease the exposed surface of the damaged 3LPE insulation.
- Heat up the place under repair with a burner to reach 40 – 60°C.

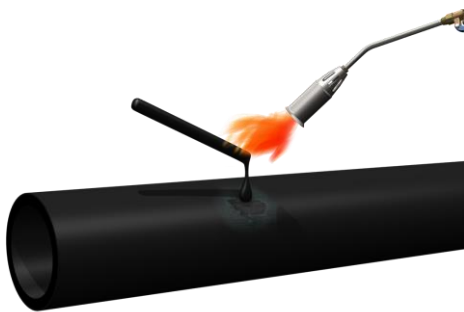
- Heat up the end of the repair stick - Melt Stick until the state of fluidity.
- Fill losses in 3LPE coating with the molten material
- Smoothen the surface of the laid sealing layer with a small, heated spatula, keeping an allowance of up to 2 mm above the factory applied coating.

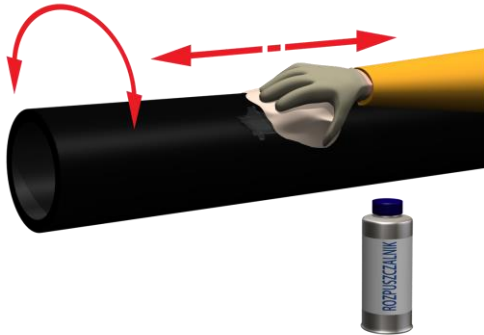
- Remove the loose 3LPE coating.
- Chamfer the edges of 3LPE coating at the damaged place, down to 15°.
- Degrease the exposed surface of the damaged 3LPE insulation.

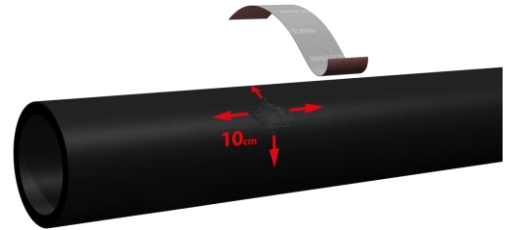
- Roughen the 3LPE Surface adjacent to the damage at a distance of 10 cm away from the edge of the damaged place.

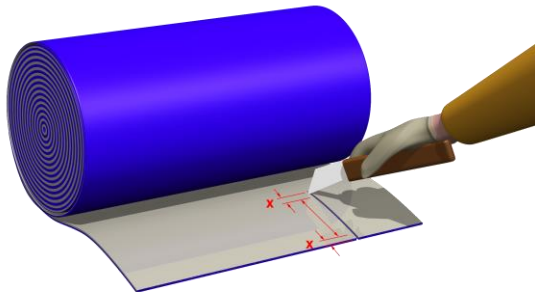
- Cut out a suitable piece of the repair patch ANTICORRay REP with a 50 mm allowance towards the edge of the damaged place.
- Round off the patch corners.

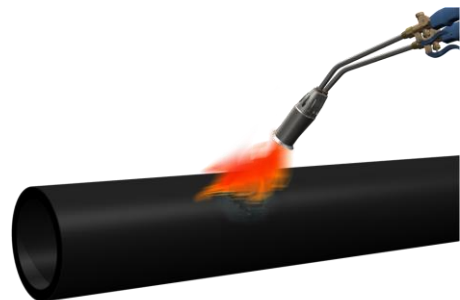
- Heat up the place under repair with a burner to reach 40 – 60°C.

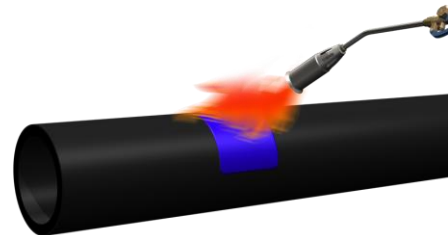
- Place the patch on the place under repair with 50mm overlap on the 3LPE coating.
- Hold the patch in the burner flame.
- Remove any air bubbles with a silicon roller.
- Stop heating up the patch when a glue flash has appeared in the periphery.
